CONDITION AND VALUATION SURVEY

Vessel Name: BOUNDARY
Vessel Type: Gulf 32
HIN: CPY00256H788

Prepared for: [REDACTED]
Date of Survey: April 17 & May 1, 2026
File No.: S320426D

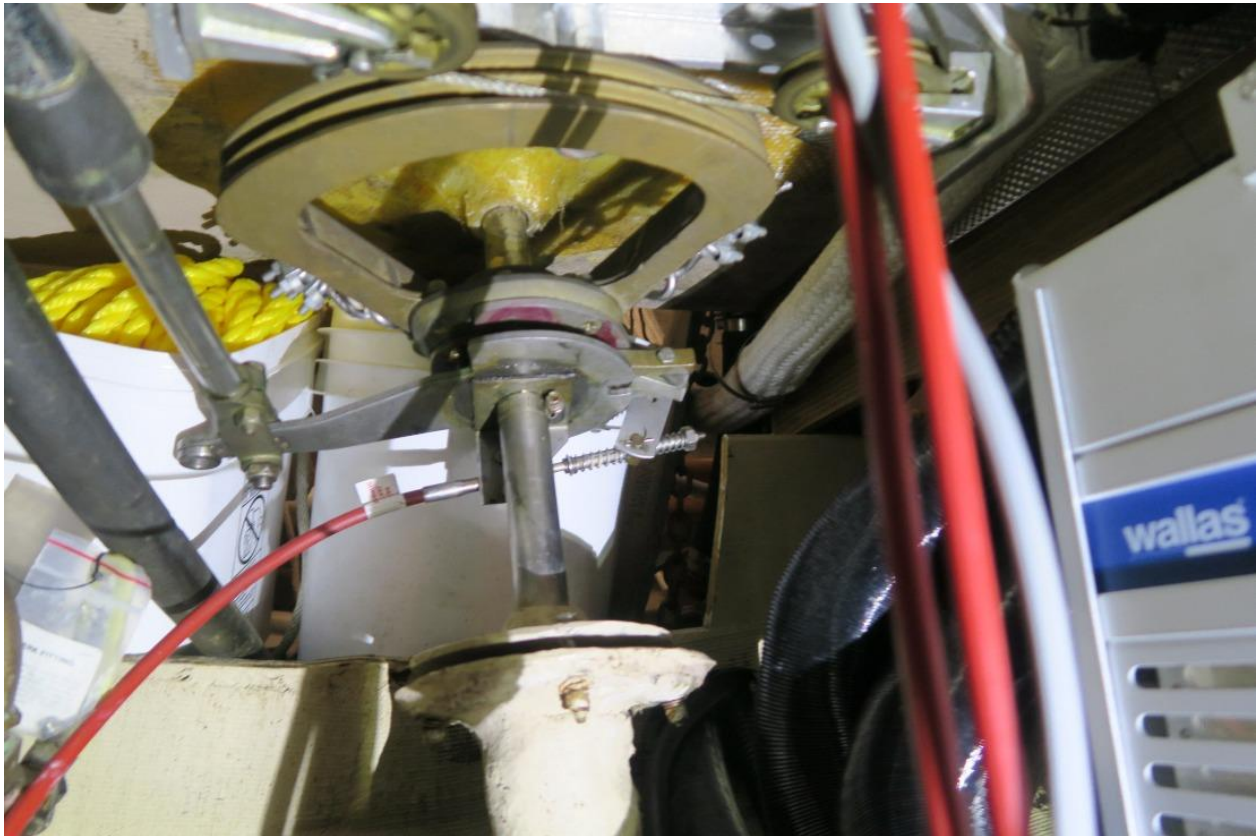
2. The steering quadrant connections to the rudder shaft has some play.
Recommendation: Check for worn parts, and secure the quadrant connections.

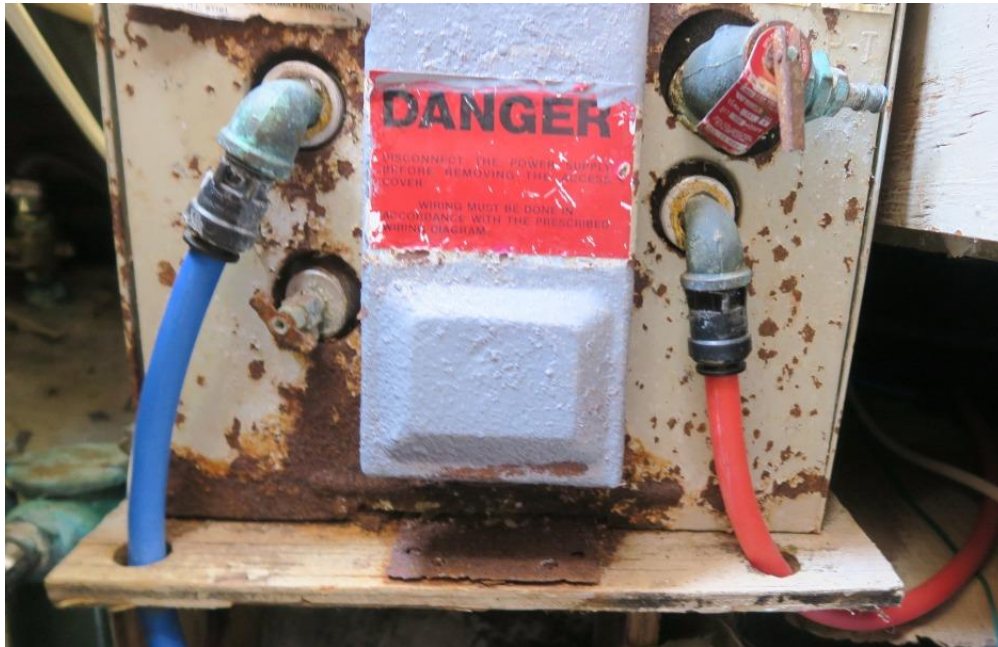
9. The alternator belt is loose.
Recommendation: Adjust as needed.
10. The current bilge pump fuse is 20A, and should be 15A.
Recommendation: Install a 15A fuse.
11. The hot water heater case is corroded.
Recommendation: Remove corrosion, paint to preserve and monitor.

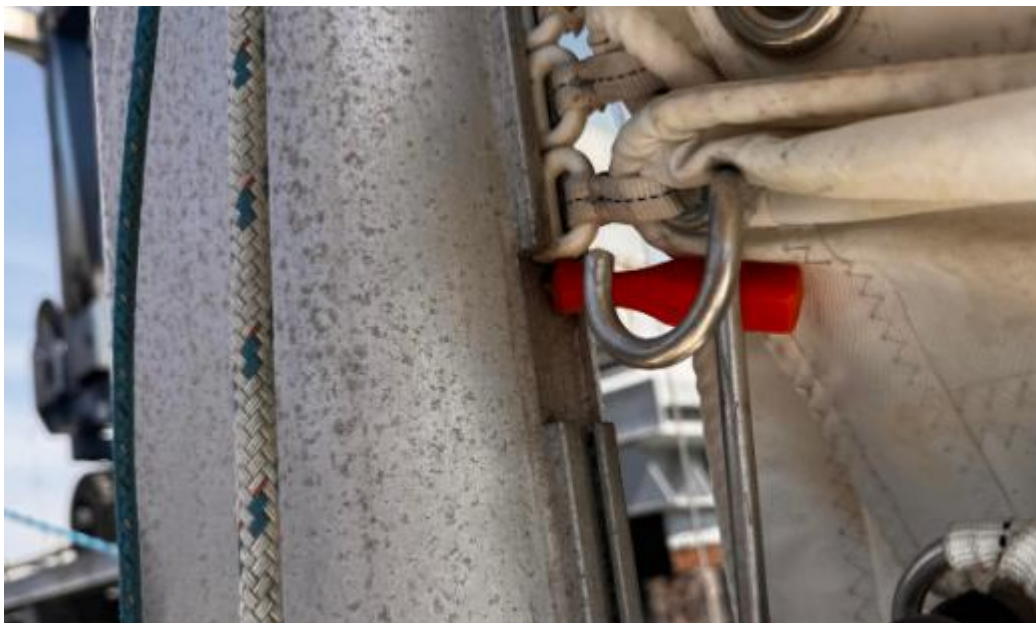
- 12. There is some corrosion on the forward engine mount and bracket.
Recommendation: Clean off corrosion and treat with anti-corrosive coating to preserve.
- 13. There is a broken light bulb in the compartment below the cockpit.
Recommendation: Replace this light bulb.
- 14. There is a screwdriver set in the sail track to prevent the sail from falling out of the track when lowered.
Recommendation: Install suitable hardware instead.

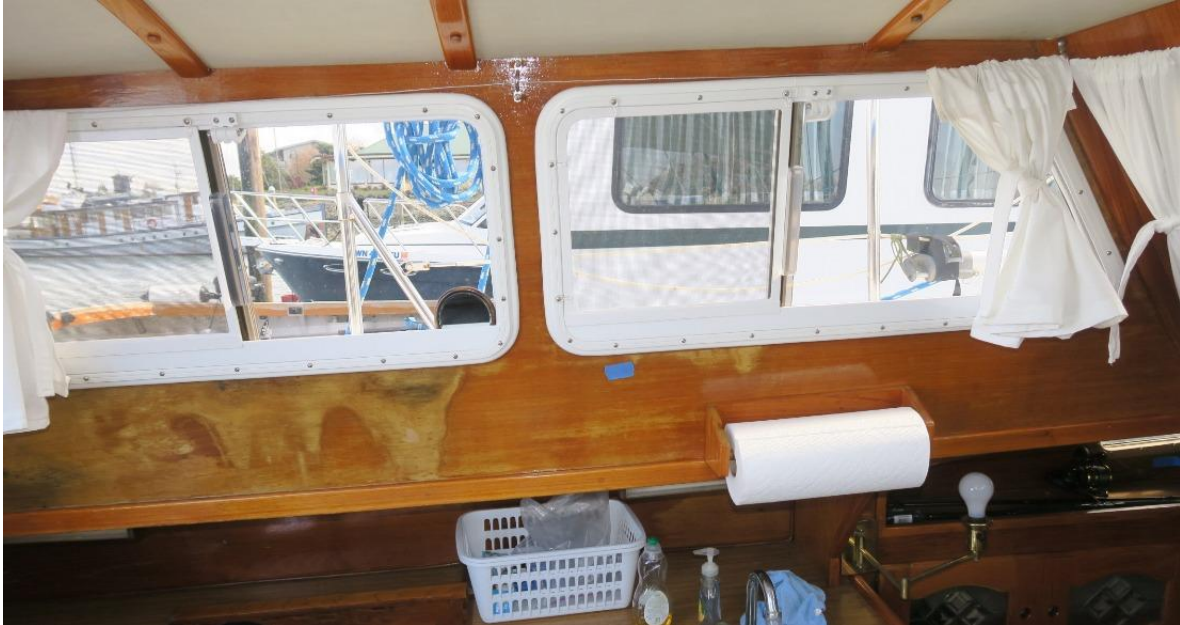
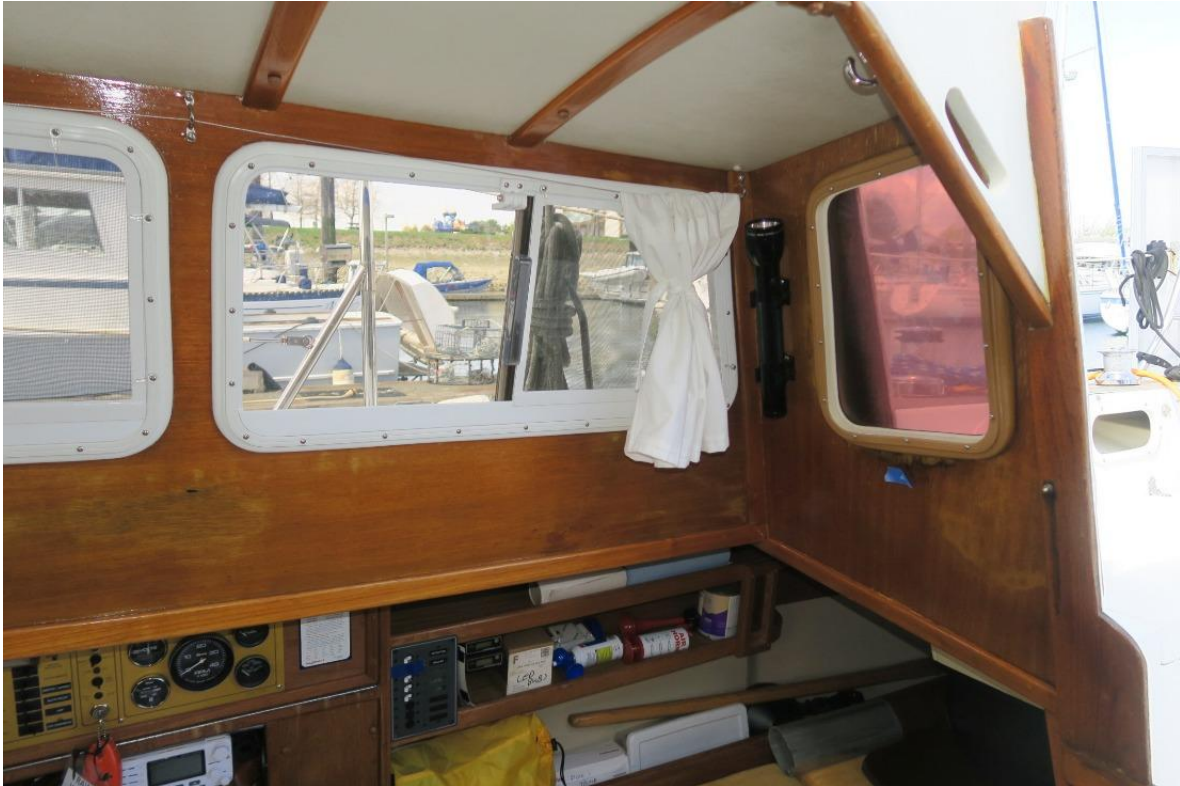
15. The original pilot house windows leaked, but have since have been replaced. Some residual moisture and staining remains in the interior woodwork.
Recommendation: Noted. Repair if desired.

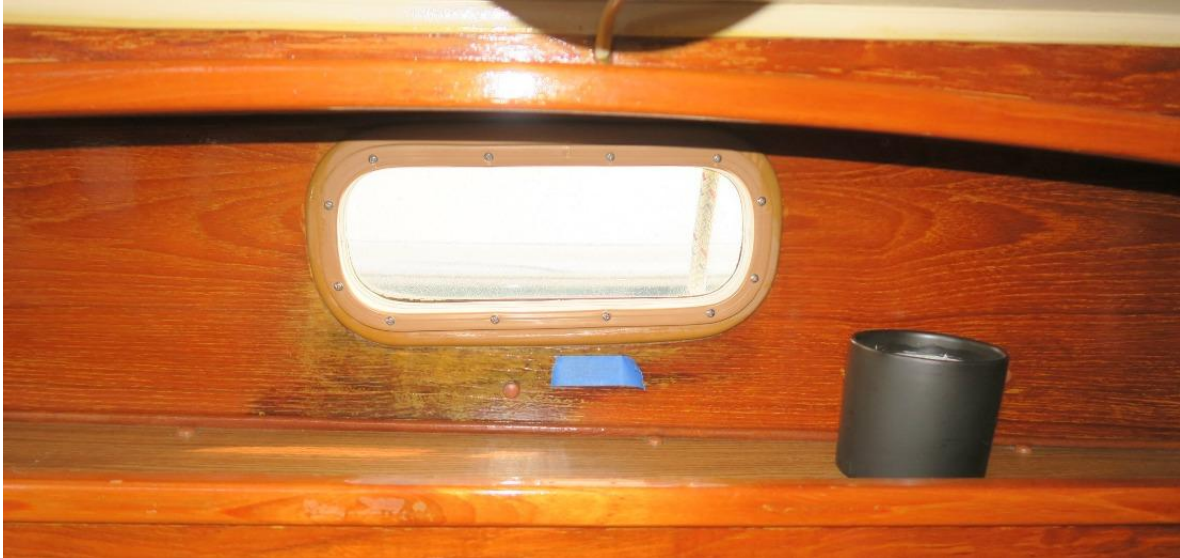
16. There is elevated moisture and staining below the port side in-hull portlight identified with blue tape in the photo below.
Recommendation: Reseal portlight, and repair woodwork if desired.

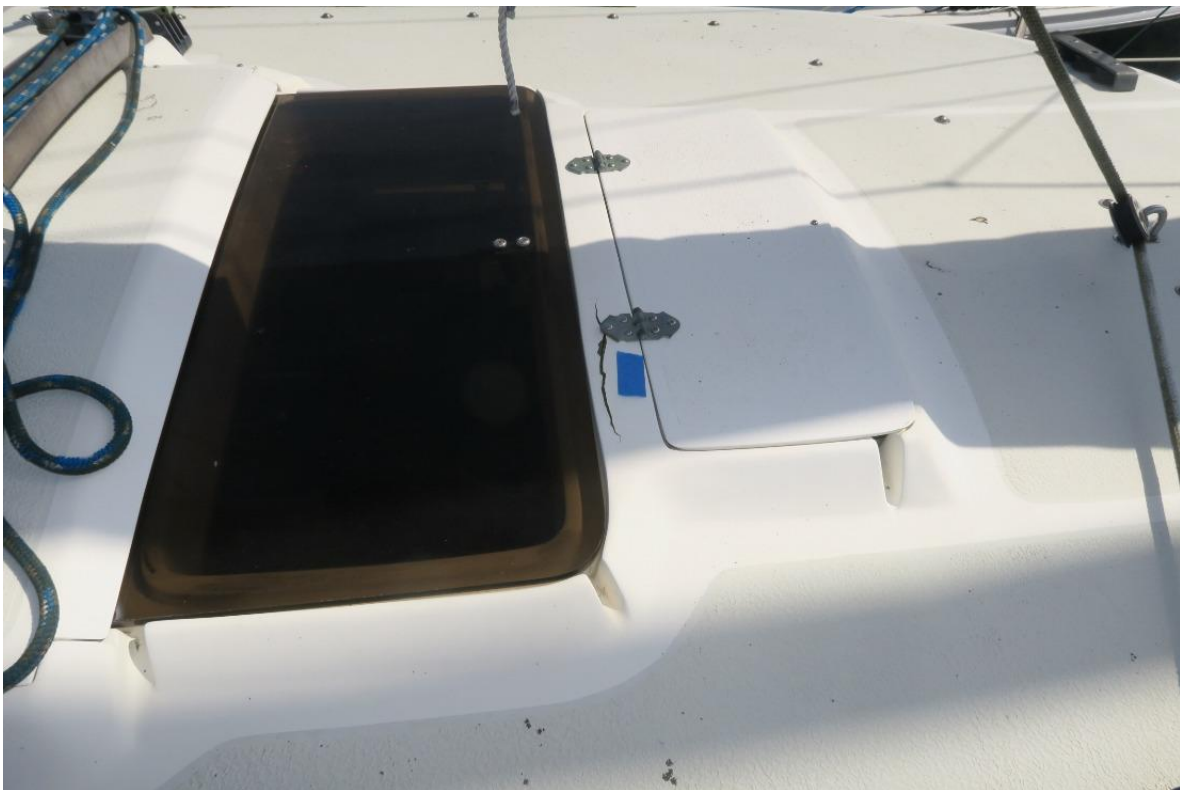
17. The cabin top locker is cracked at the hinge mount, and elevated moisture was detected.
Recommendation: Plan to repair fiberglass.

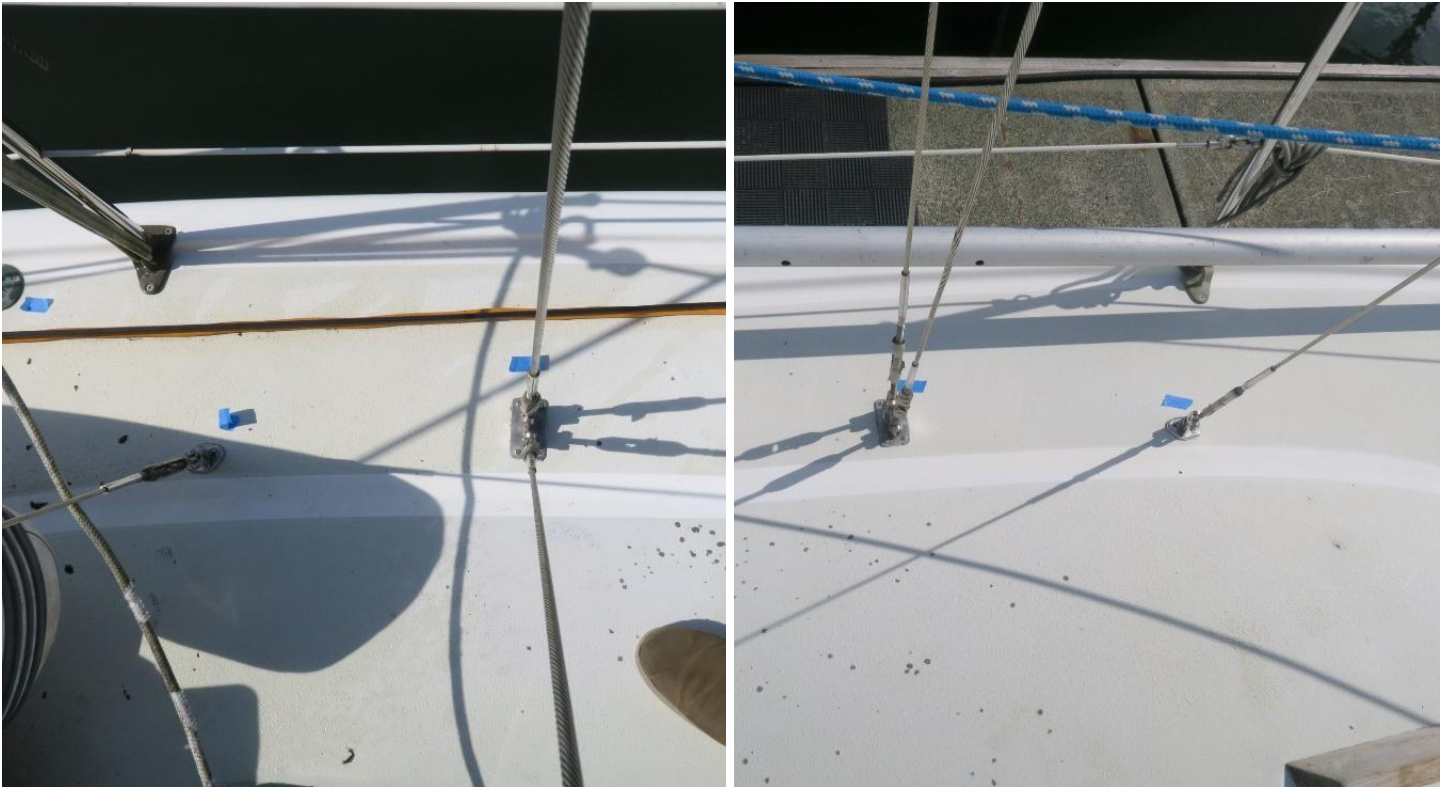
18. Elevated moisture was detected in the cored deck at each of the chainplates. It is reported that three of the four chainplates were resealed in 2021.
- Recommendation: Considering the chainplates have been exposed to prolonged moisture in the deck, they should be inspected for corrosion. While the plates are removed, check the core material at the chainplate penetrations for deterioration, and repair and/or dry out as needed. Check the chainplate knees for any water damage and repair if needed. Remove the core around the deck penetrations if necessary and seal out with epoxy. Reinstall the chainplates using new stainless steel 316 grade fasteners.

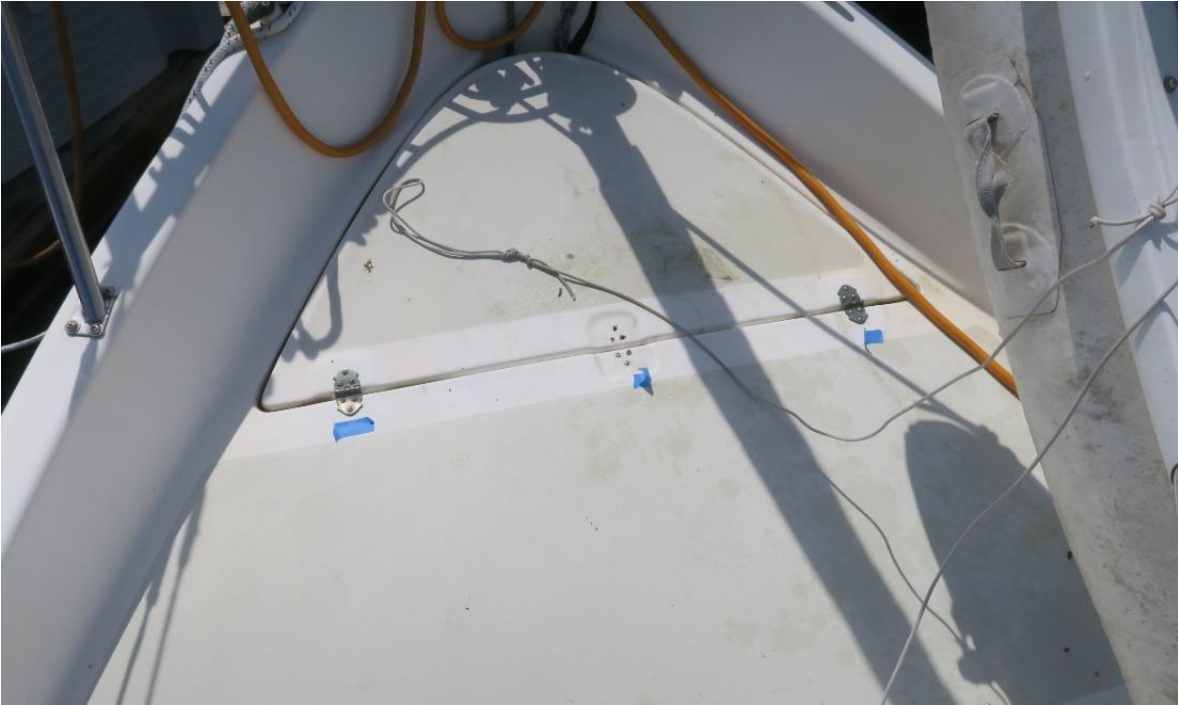
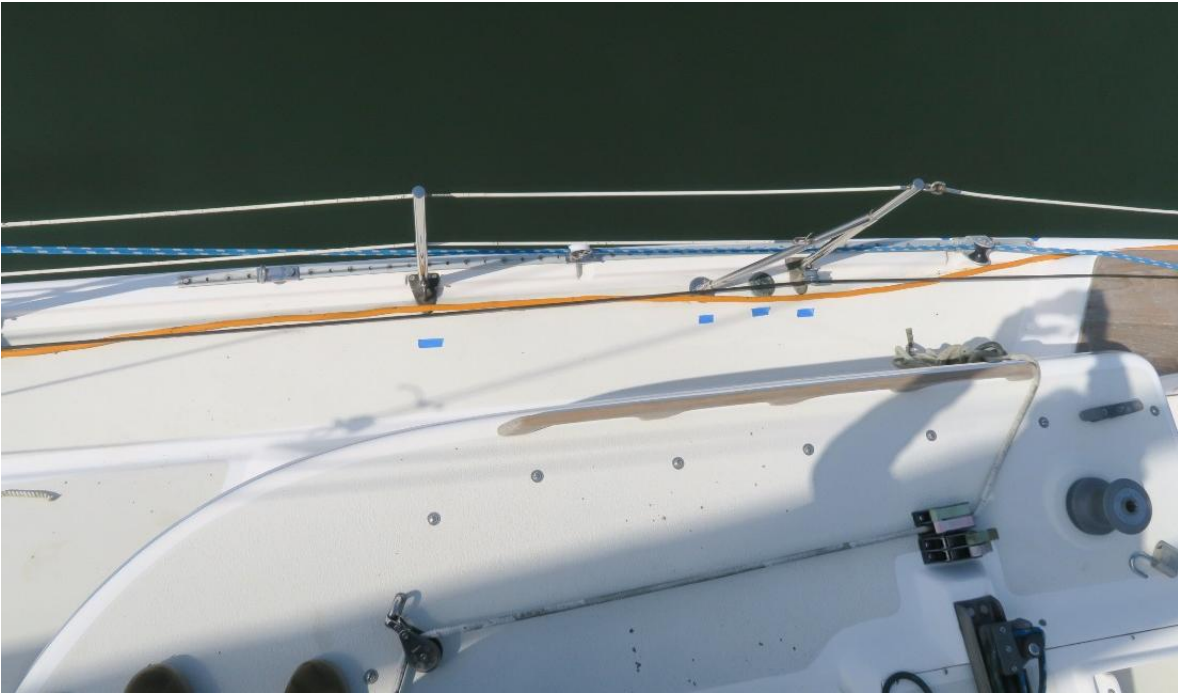
19. Moisture reading identified other areas of elevated moisture, indicated with blue tape in the photos below.
- Recommendation: While it is important to rebed all deck hardware as part of long term maintenance, clearly the hardware in these areas should be rebedded first. Remove the hardware, checking the condition of the core material at the penetrations. Allow the areas to dry for a time before re-installation of hardware. Consider a positive close out of the core at the penetrations, by local removal of the core, making the area solid with epoxy filler, and re-drilling for the fasteners through the new solid material. Use suitable marine sealant when re-installing the hardware.
