# **Marine Consultants, Inc.**

## **CONDITION AND VALUATION SURVEY**

**File No. S320121D**

Vessel Name: BOUNDARY Date of Survey: January 2 & 14, 2021  
Home Port: Hailey, ID Official No.: 1028331 Hauled: 01/02/2021  
Location of Survey: Seaview Boatyard Fairhaven and Squalicum Harbor Afloat: 01/14/2021  
Marina, Bellingham, Washington  
Requested by: Sebastian Sears  
Owner: Same  
Builder: Capital Yachts Designer: Wm. Garden Model Year: 1988  
Type of Vessel: Gulf 32 Displacement: Unknown  
Hull No.: CPY00256H788 LOD: 32' LWL: 25' Beam: 10' Draft: 5'-2"

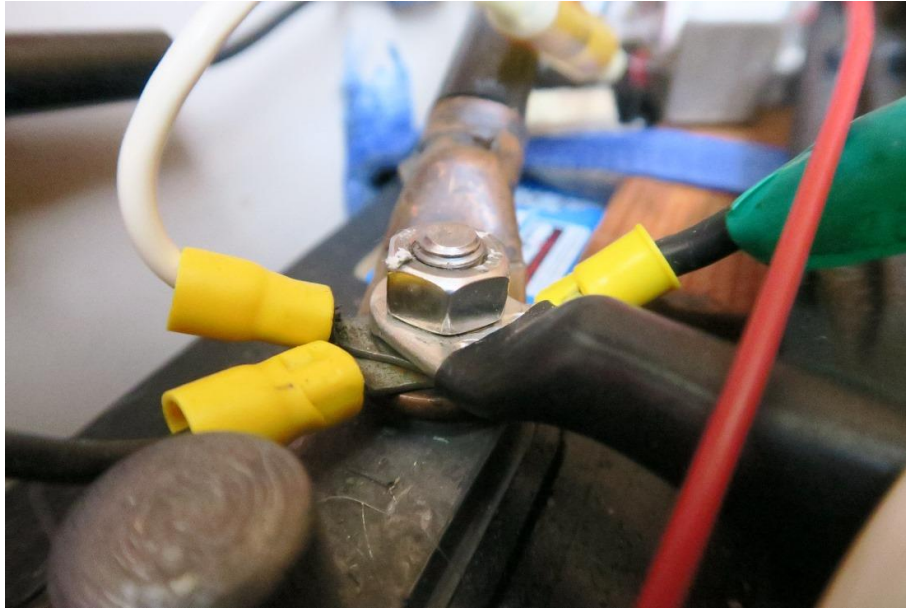
2. \* Other battery wiring issues include the following:
  - a. In one or more cases, five conductors have been connected to a terminal stud.  
Recommendation: ABYC standards call for a maximum of four conductor ring terminals on a stud, to avoid high resistance connections. A separate positive buss bar should be used.
  - b. In one or more cases, the connected conductors to the battery terminal studs have been incorrectly stacked, including on the starter motor.  
Recommendation: ABYC standards call for the largest conductor ring terminals to be at the bottom ranging up to the smallest at the top under the securing washer and nut, for lowest resistance connections.
  - c. The battery cabling prevents opening most of the battery covers in order to check the electrolyte levels.  
Recommendation: Re-route the cabling as needed to access the covers.

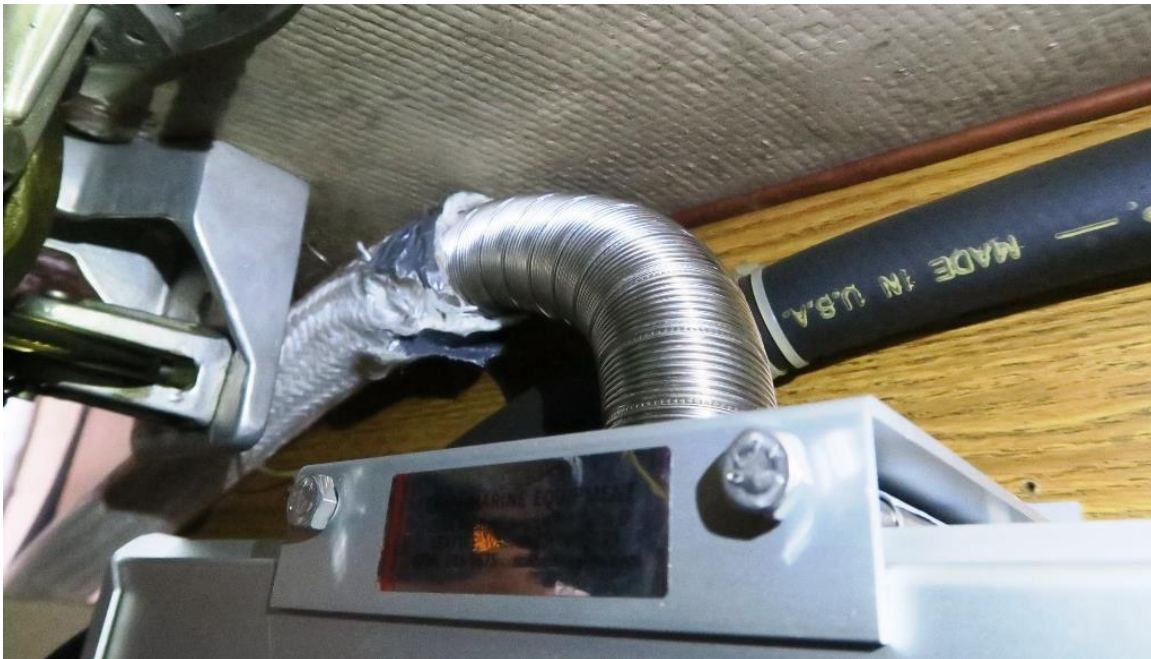
- c. The furnace exhaust is unsupported in the lazarette compartment, where gear is stored.  
Recommendation: Support the furnace exhaust with metal standoffs, and create a barrier to prevent gear from contacting exhaust.
- d. The furnace exhaust is insulated, but does not have insulation for the first six inches at the furnace. This uninsulated exhaust contacts the fiberglass overhead above.  
Recommendation: Add insulation to this section, and re-mount furnace slightly lower to create an air space between the exhaust and the overhead. Add heat shield to overhead if needed.

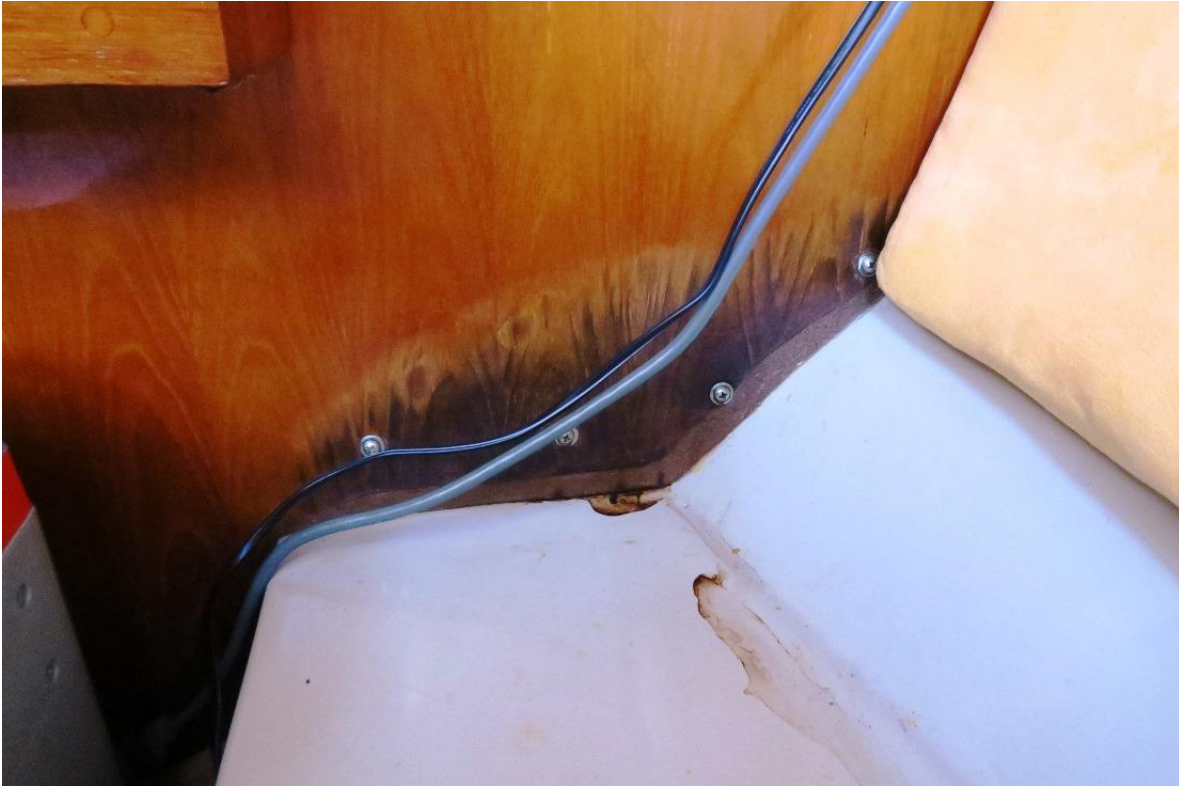
17. There is moisture damage to the lower portion of the starboard plywood bulkhead that measures damp using a GE Protimeter Aquant moisture meter. The water source is unknown. Note that the bulkhead in the area of the chainplates measures dry, and is not moisture damaged.

Recommendation: Plan to repair woodwork, and monitor area for leaking.

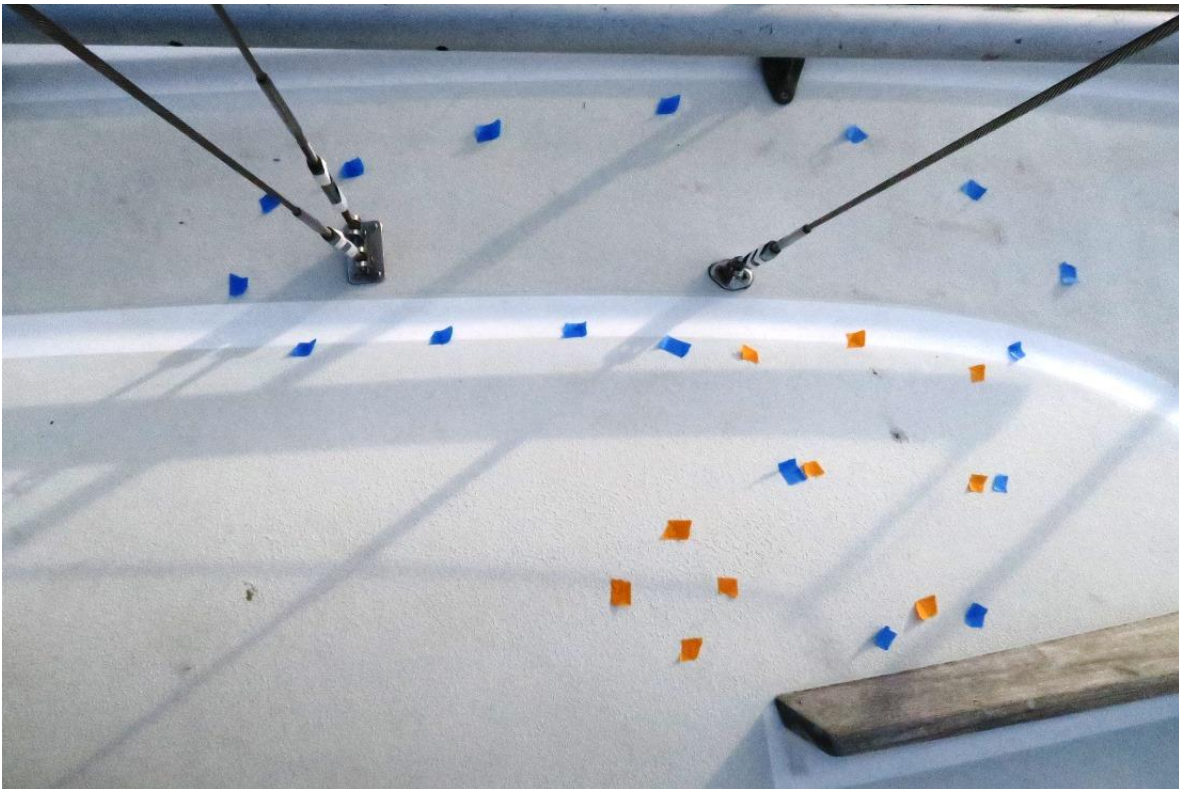
- a. The port side deck and cabin top in the area of the chainplates shows elevated moisture, marked in blue tape in the photo below.  
Recommendation: Remove the chainplates and clean and inspect for any corrosion or cracking. While the plate is removed, check the core material at the chainplate penetrations for deterioration, and repair and/or dry out as needed. Check the chainplate bulkhead for any water damage and repair if needed. Remove the core around the deck penetrations if necessary and seal out with epoxy. Reinstall the chainplates using new stainless steel 316 grade fasteners.

- b. A section of the port cabin top has two areas that are delaminated or have compromised core material, marked in orange tape in the photo above. The aft (left side) area is a void with perimeter stress cracks, and the forward area appears to have two holes that were inadequately repaired, and may have allowed water ingress, compromising the core.  
Recommendation: Have a fiberglass technician repair these areas using best marine practice.

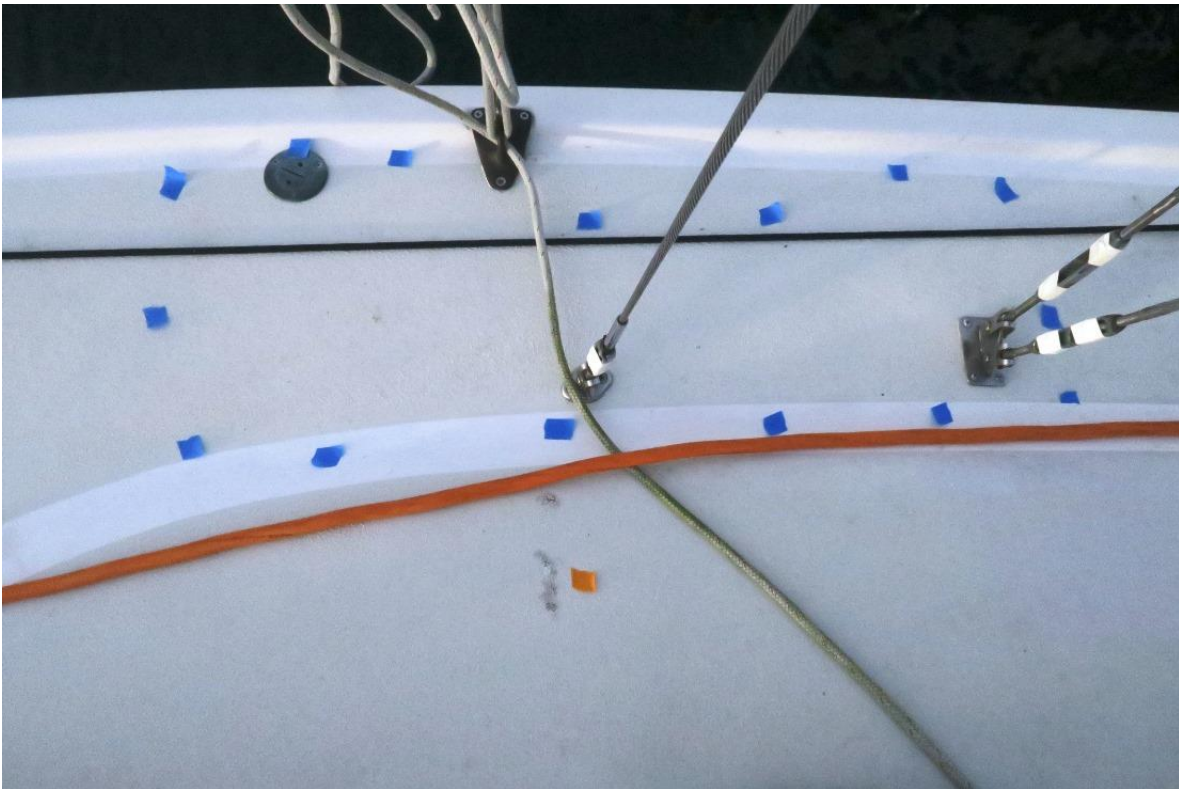
- c. The starboard side deck and cabin top in the area of the chainplates shows elevated moisture, marked in blue tape in the photo below.  
Recommendation: Remove the chainplates and clean and inspect for any corrosion or cracking. While the plate is removed, check the core material at the chainplate penetrations for deterioration, and repair and/or dry out as needed. Check the chainplate bulkhead for any water damage and repair if needed. Remove the core around the deck penetrations if necessary and seal out with epoxy. Reinstall the chainplates using new stainless steel 316 grade fasteners.

- d. There are fastener holes on the starboard cabin top that have been inadequately repaired, marked with orange tape in the photo above.  
Recommendation: Have a fiberglass technician repair this area using best marine practice.

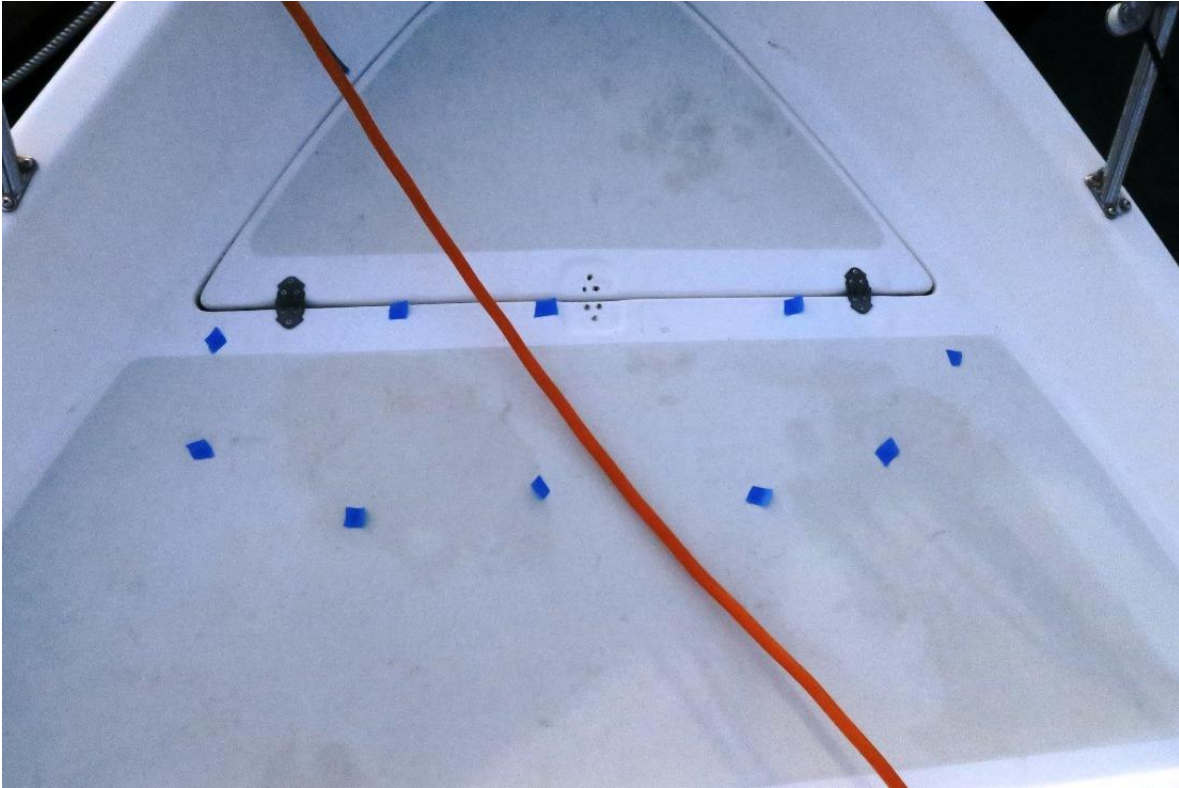
- e. A section of the foredeck shows elevated moisture, marked in blue tape in the photo below, and there are open holes where a hinge was mounted.  
Recommendation: Install a hinge and seal the holes to prevent further water ingress. Consider a positive close out of the core at the penetrations, by local removal of the core, making the area solid with epoxy filler, and re-drilling for the fasteners through the new solid material. Use suitable marine sealant when re-installing the hardware.
