Marine Survey Report. SNS15-26

MARINE SURVEY REPORT FOR S/V SATORI

On 13 July 2015 at the request of David Motherwell for Mr. Barrett our firm performed a pre-purchase marine survey of a 1988 Gulf 32. The vessel was located at Skyline Marina, Anacortes, WA. Said vessel hull and systems were inspected to determine its condition and value. Present during survey were David Motherwell (broker), Mr. and Mrs. Barrett (buyers) and Steve Hayes (surveyor).

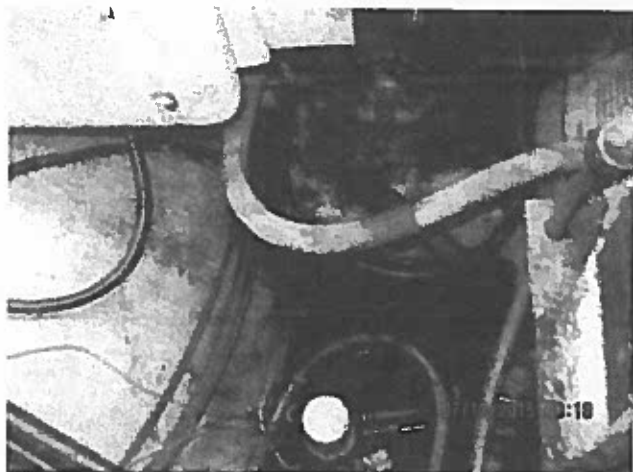
-ENGINE(S): Universal 40. Reported to have approximately 1700 hrs. Engine was visually inspected and tested with laser temp gage during operation. Engine start and operation was normal. Oil level was full. Oil is very black, but did not smell burnt. During operation, temperatures were normal. There is a large amount of oil in the bilge under engine. Source of the oil is not known, Spilled during maintenance or a bad engine seal? Watched for oil leaks during operation and did not sight any. Engine mounting is good. There is some surface rust on portions of engine. Engine is oily.

Dirty bilge. Rusty engine.

- ✓ 16. Hose clamps for drain hose from shower sump are corroded. Replace hose clamps. *CLEANED AND REPLACED*
- ✓ 17. Bilge under engine has large amount of oil in it. Clean with absorbent pads, clean with degreaser. This needs to be completed so no oil gets into the environment. *CLEANED WITH DEGREASER AND ABSORBENT PADS*

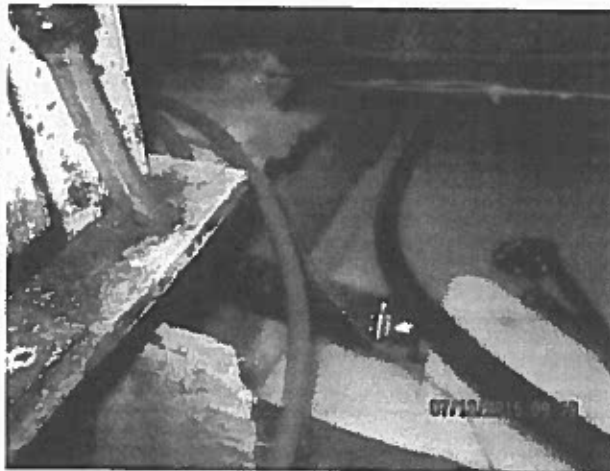
Photo of area where bulkhead is cut-out

- 3. Fuel tank is not secured. It must be strapped or made so it cannot move out of position, including up. Ref; ABYC H-33.
- ✱ 4. Bulkhead aft of fuel tank was cut during installation of new fuel tank. It is our recommendation that this bulkhead be restored to original. They don't put bulkheads in vessels for looks. This is a structural component of hull.

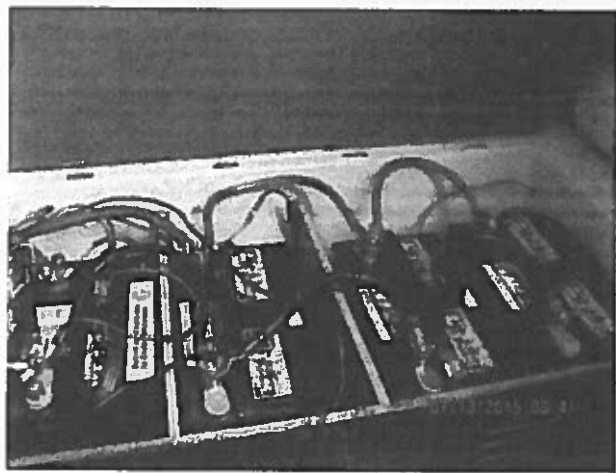
-BATTERIES: Four 12-volt batteries. Need to be secured. Wing-nuts on connections need to be removed and nuts installed.

Batteries not strapped down.

- ✓ 13. Batteries need to be secured. They must be strapped down so they cannot move. Ref; ABYC E-10.
Installed STRAP AND SECURED REPLACED 3 HOUSE BATTERIES STRAP

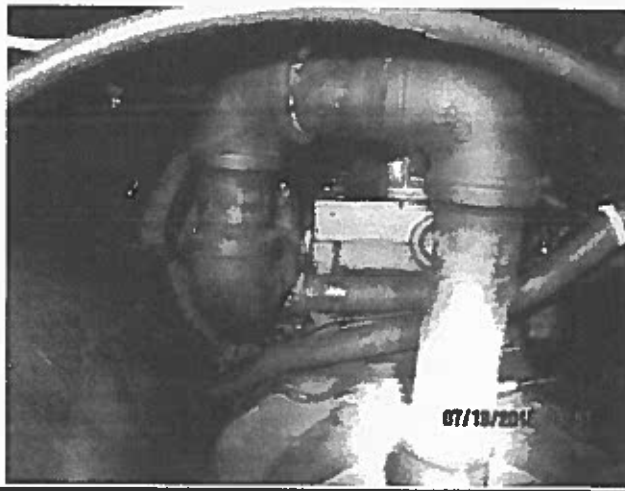
Exhaust piping that should be insulated.

- ✓ 6. Alternator belt is loose. Tighten belt and secure alternator. *TIGHTENED AND SECURE*
- ✓ 7. Exhaust system piping at rear of engine needs to be wrapped with insulating material. *REPLACED EXHAUST PIPE AND INSULATED*

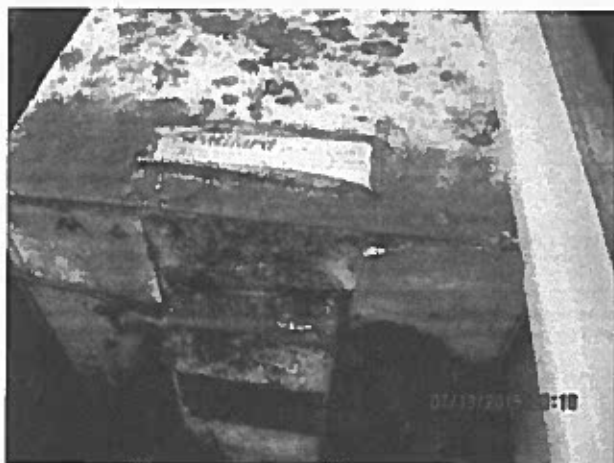
-HOT WATER HEATER: Seaward 6-gallon hot water heater, which operates on 110-volt A/C or engine heat. Not tested, as there was not any water in system. Hot water heater is mounted in forward port side of engine bay. Heater is severely corroded on exterior. Looks at the end of its life.

Rusty Hot water heater.

- ✓ 13. Install GFI A/C outlets in galley and head. Ref; ASBYC E-11.
- ✓ 14. VHF radio inoperable. Repair or replace radio. *REPAIRED*
- ✓ 15. Hot water heater is severally corroded externally. Recommend replacement.

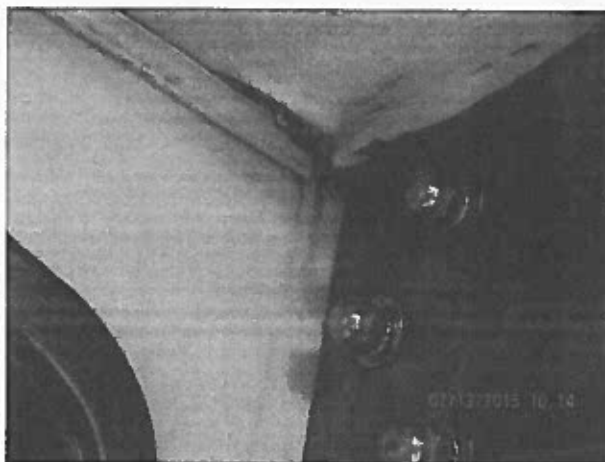
-BULKHEADS AND CEILINGS: Bulkheads well attached to hull with the exception of a portion of the bulkhead, which is accessed inside head vanity cabinet. This bulkhead has some loose tabbing. The bulkhead forward of the engine room has been cutout to remove old fuel tank. After new tank installed, the bulkhead was not replaced. The ceilings are in good order, except on the starboard side near the forward cabin bulkhead. Moisture appears to have entered around hatch in head. Water stains can be seen near chain-plate and seam in headliner aft of forward cabin bulkhead is separating.

Leak in ceiling at starboard chain-plate area.

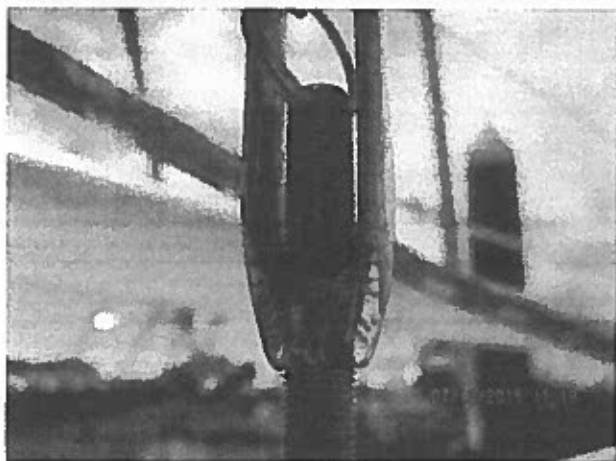
-STANDING RIGGING: Stainless steel wire rope with swaged end fittings. Turnbuckles connect stays to chain-plates. Rigging was visually inspected from deck level. The port side, upper stay for mast has a cracked lower swage end fitting. Turnbuckles show signs of their age, recommend rigger inspect, replace if required. Chain-plates appear in good condition and well attached. Many of the safeties in rig are wire and have loose ends that are snagging hazards.

Rigging Turnbuckle, note stress, corrosion.

- ✓ 1. Swaged end fitting for port side upper mast stay is cracked. Replace cable assembly. *Replaced port and starboard*
- ✓ 2. Turnbuckles in standing rigging are old. Should have rigger inspect and replace if required. Have standing rigging inspected for safety reasons. *Had inspected Replaced Both portside and starboard CAP STANDING RIGGING*

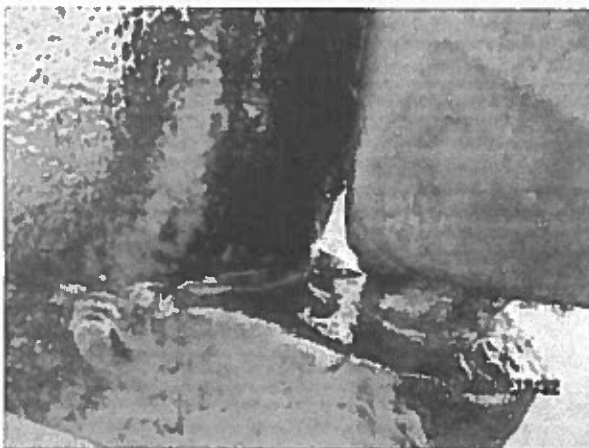
-RUDDER: The rudder is cut-away on leading edge to allow room for propeller. There are two shafts connected by an iron plate internally in rudder, these are foamed over, than fiberglassed after shaping. Rudder inspected visually and with hammer soundings. Visually no defects noted, hammer sounding were unremarkable. The rudder had some upper movement, bearings and bushings were in good condition. Again, the main concern here is the shoe attached to keel. During next haul-out for maintenance, the shoe should be removed. Inspect the bolt holes in hull and shoe for elongation.

Shoe for rudder, note rust area. This has movement.

1. Shoe for rudder, which is attached to lower aft end of keel and supports the rudder has some movement. Recommend investigating at next scheduled haul-out. Remove shoe fitting, inspect bolts, bolt-holes and shoe. Repair if required. Reinstall using new hardware.
