**REPORT OF MARINE SURVEY**  
**PRE-PURCHASE CONDITION & VALUE**  
of the vessel  
**"Vera L"**  
**1988 Gulf 32 Pilothouse Sloop**

**Vessel Yr/Make/Model:** 1988 Gulf 32 Pilothouse Sloop.  
**Report file no:** FD15-2086.  
**Inspection date(s):** 10/12/2015.  
**Date of written report:** 10/16/2015.

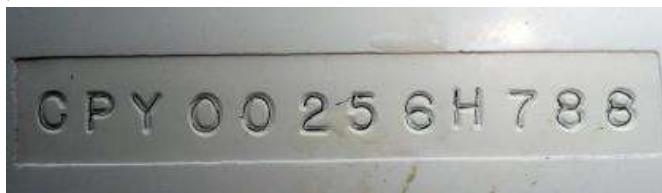
**CPY00256H788** The original HIN was molded into the transom but was difficult to photograph so it was pencil/chalk enhanced to show more clearly. A true digital photograph of the hull ID number of the referenced vessel is shown here.

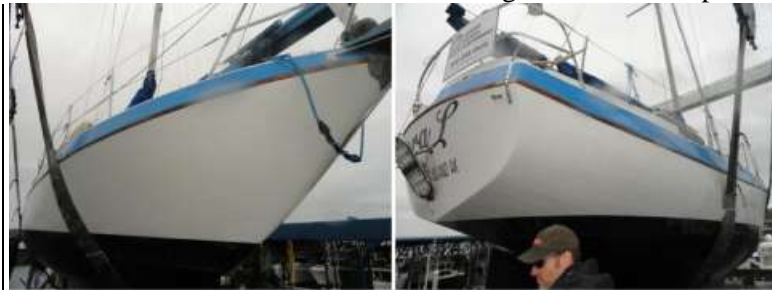
**Hull cosmetics:** Excellent condition-Well protected and no severe external scratches chips or abrasions sighted. Hull was polished and clean.

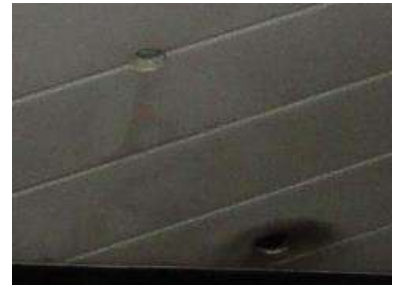
**Side thru hull fittings:** Most thru-hull fittings are fiberglass tubes integrally molded with hull - no cracks observed. One bronze mushroom-head thru hull fitting adequately secured and sealed to hull.

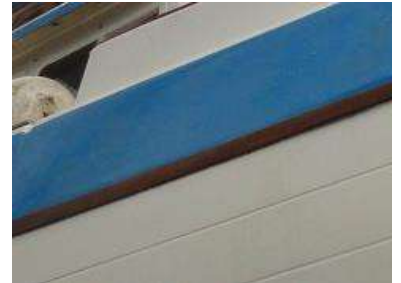
**Rub rail:** Rub rail is small teak cover strip approx 1" x 1/4" ; Rub rail is in excellent condition. No gouges or dents in rail.

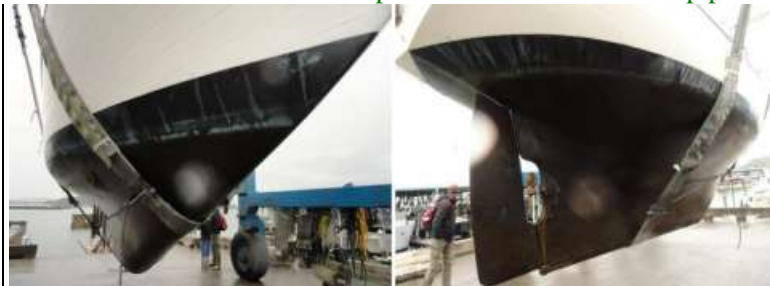
Anti-fouling bottom paint in good condition. **Minor areas of flaking bottom paint noted, especially just forward of propeller-aperture. Remove loose flaking paint, spot sand areas and touch up peeling/flaking areas prior to next launch.**

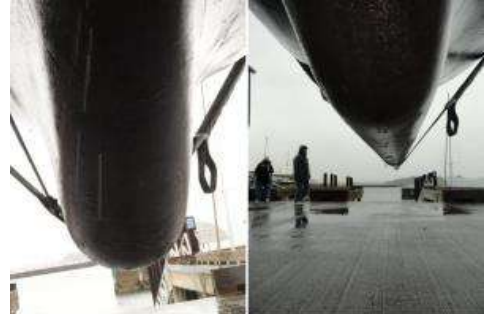
No evidence of prior grounding or collision/allision. Random percussion hammer testing showed no apparent evidence of any delamination of fiberglass from ballast.

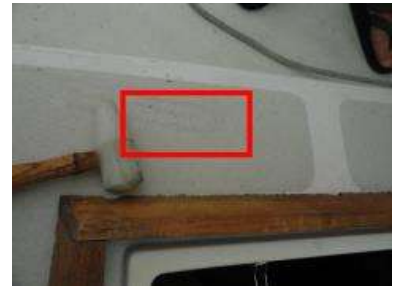
Moisture meter readings on top and side decks and surrounding thru deck fittings were relatively dry with normal comparative moisture meter readings. No Delamination discovered when randomly testing with percussion hammer. Moisture meter readings on top and side decks and surrounding thru deck fittings were relatively dry with normal comparative moisture meter readings. EXCEPT: slightly elevated moisture in way of chainplates on both side-decks; percussion-tapping in that area does not suggest separation of deck layers, and is solid underfoot; **RECOMMENDATION: rebed chainplates, deck thru-bolts, and chainplate covers to lessen any further moisture ingress.** No Delamination discovered when randomly testing with percussion hammer. EXCEPT: small 4"x6" dia area of delamination of top skin from core, found just forward of foredeck sliding hatch frame. No higher moisture readings in thee areas; slight cracking of deck surface at periphery of delaminated area , solid underfoot. May have been a manufacturing defect. **RECOMMENDATION: to avoid spreading of the delamination, a cautious approach would be epoxy-injection to re-bond deck layers; as there is no high-moisture present, this area is a likely candidate for this method of repair.**

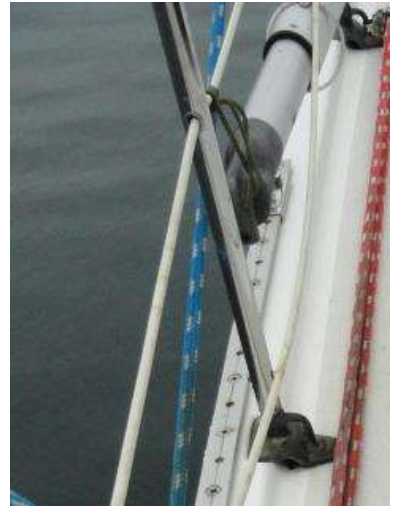
Stainless steel, Well secured. Bronze bases capture bolting to both deck and top of low bulwark.

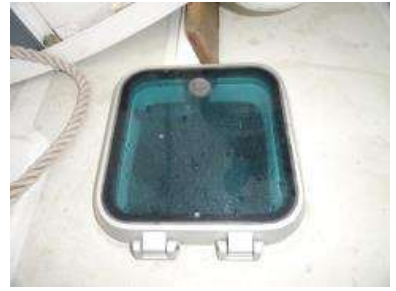
one small square Lewmar ventilation hatch. Appears secure; latch operable. No leaks observed.

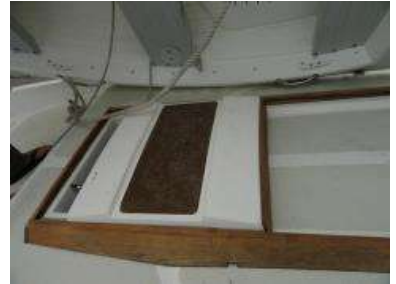
Sliding fiberglass hatch, translucent by means of no gelcoat in center - well-supported in teak tracks. Smooth operation; no apparent leakage.

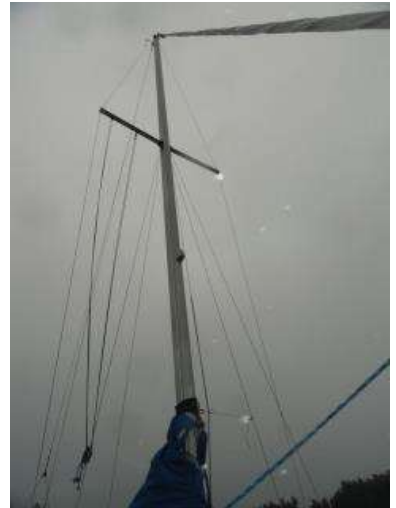
Aluminum, anodized. Some surface corrosion, but this minimal pitting is not deep enough to degrade structural strength. Mast was stepped and Appears to be in column, Mast and fittings appeared to be in very good condition. All standing rigging was only inspected at deck/eye level as mast was up. --- Recommend full inspection of standing rigging by a qualified rigger who will go aloft or drop mast for further inspection of all standing rigging components.

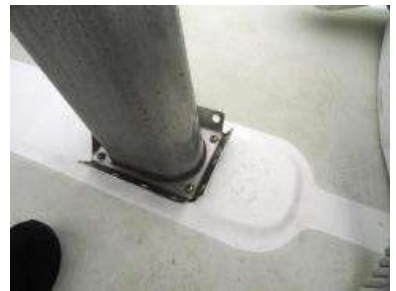
Mast is deck stepped with stainless steel mast step securely fastened to a reinforced mast step pad area. Deck is solid and does not appear compressed at mast step area.

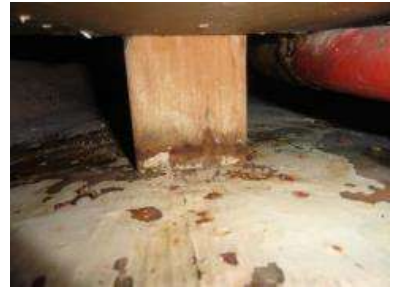
Compression post inside cabin is wood and is solid top and bottom. Bottoms out on solid fiberglass top-of-keel structure. No cracks, soft spots or rot sighted.

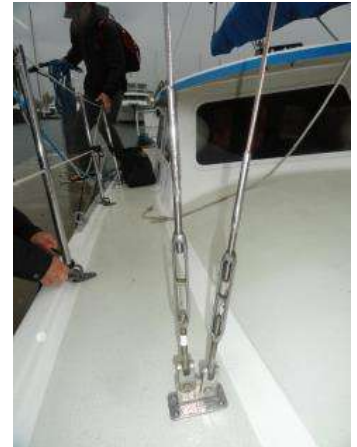
Swaged-Stainless steel, Good condition-No corrosion or bent or damaged swage fittings.

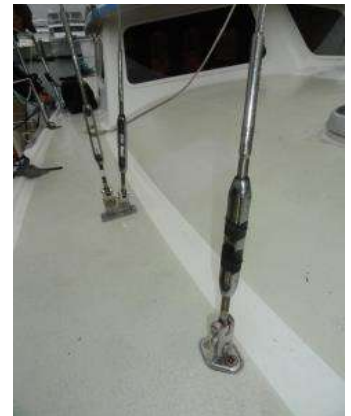
Chromed bronze open barrel, No cracks or corrosion sighted on turnbuckles. Cotter pins Installed and secure on all turnbuckles.

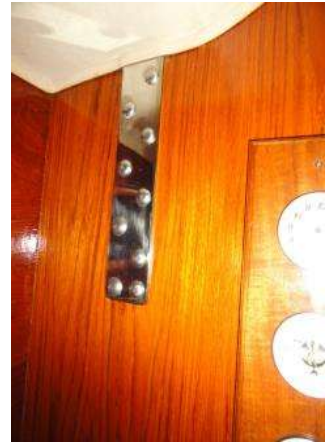
Uppers and aft lowers come to same chainplates thru-deck attached to bulkheads in cabin; forward lowers have thru-bolted deck-plate. Bulkhead connection shows no movement, nor any moisture damage of wood; bulkhead taps solid.

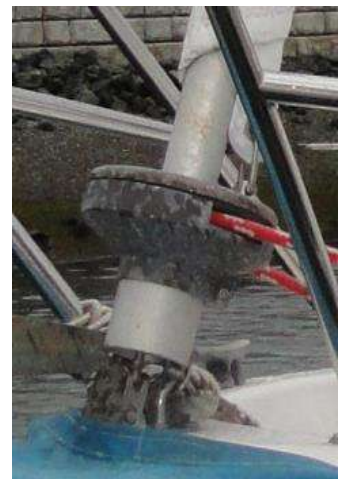
Hood Sea Furl, 810 LD, with Continuous loop furling line in very good condition (appears recently replaced), Sail partially unfurled/furled -- fully functional.

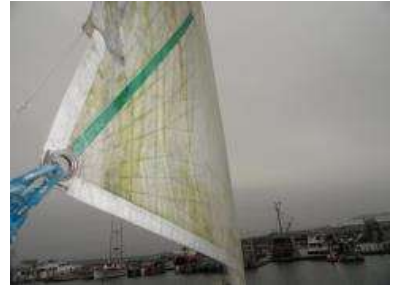
Appears in good condition, no holes or split seams sighted and head, tack, clew and grommets intact. Serviceable. Slight green-algae staining at outermost roll; suggest hand-cleaning.

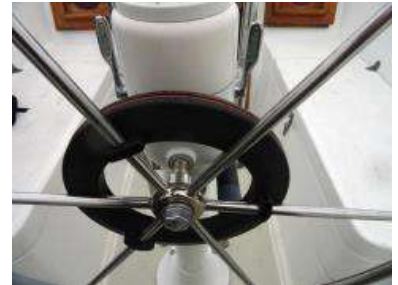
Mounted at pedestal on wheel: Autohelm wheelpilot. Remote found adjacent to inside helm. Actual control box reported available, but not sighted aboard; could not confirm operation.

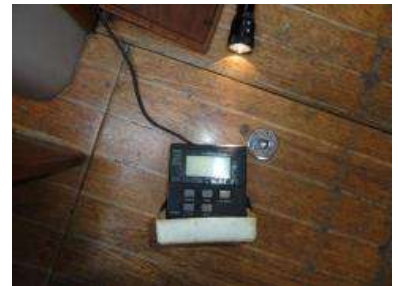
Mounted at lower helm: Navico DL200 slave display- does not power up. Found loose (but connected) in portside lazarette (to pull out for cockpit mounting) Navico RL200 digital display with controls - powers up, but screen almost unreadably dim.

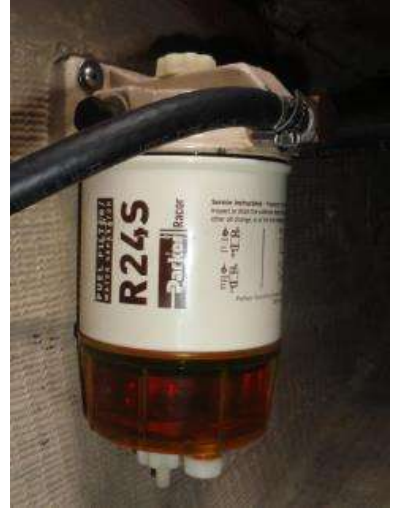
**Fuel filter(s):** Racor spin-on Fuel filter/water separator. Clear- No water sighted in lower bowl. Filter has plastic bowl AND plastic drain-valve that will not pass current flame impingement requirements as referenced by ABYC H-33, required on ALL components in diesel fuel system (test protocol in 33 CFR 183.590 ()). **RECOMMENDATION:** replace plastic drain-valve with metal plug; replace filter-bowl with metal bowl, or replace entire filter with a unit meeting current ABYC standards. If a drain-valve is desired, be sure to install metal valve approved by UL for this service (available thru Racor)
