Marine Survey Report. SNS15-26

MARINE SURVEY REPORT FOR S/V SATORI

On 13 July 2015 at the request of David Motherwell for Mr. Barrett our firm performed a pre-purchase marine survey of a 1988 Gulf 32. The vessel was located at Skyline Marina, Anacortes, WA. Said vessel hull and systems were inspected to determine its condition and value. Present during survey were David Motherwell (broker), Mr. and Mrs. Barrett (buyers) and Steve Hayes (surveyor).

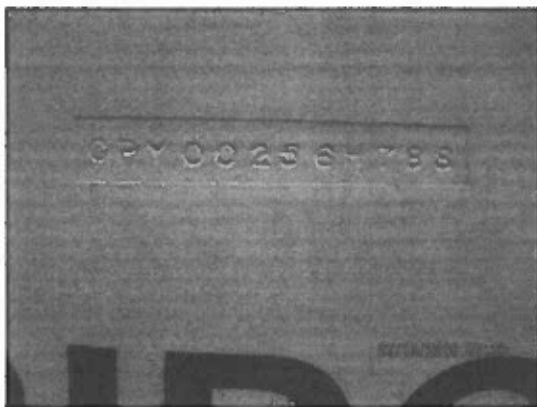
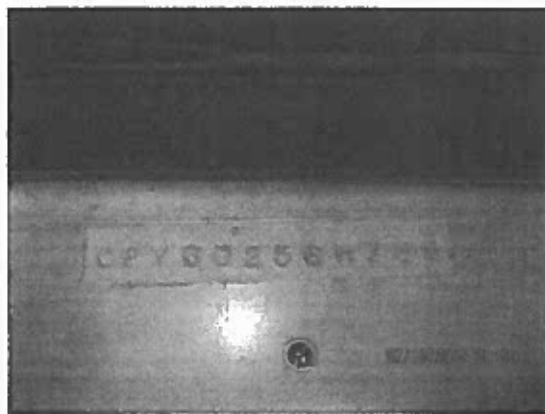
Photos of HIN numbers on outside and inside of hull.
