**REPORT OF MARINE SURVEY**  
**PRE-PURCHASE CONDITION & VALUE**  
of the vessel  
**"Vera L"**  
**1988 Gulf 32 Pilothouse Sloop**

**Vessel Yr/Make/Model:** 1988 Gulf 32 Pilothouse Sloop.  
**Report file no:** FD15-2086.  
**Inspection date(s):** 10/12/2015.  
**Date of written report:** 10/16/2015.

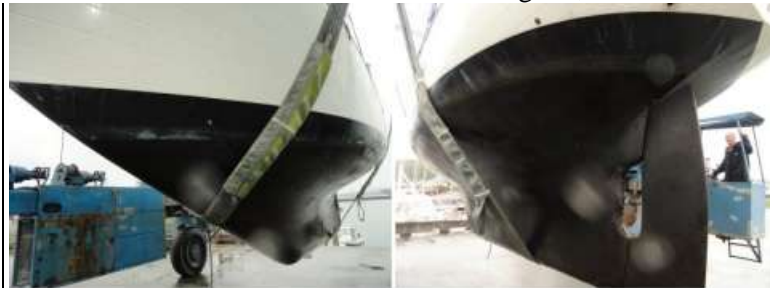
Molded fiberglass, No cracks or separation sighted on any portion of hull bottom.

Anti-fouling bottom paint in good condition. **Minor areas of flaking bottom paint noted, especially just forward of propeller-aperture. Remove loose flaking paint, spot sand areas and touch up peeling/flaking areas prior to next launch.**

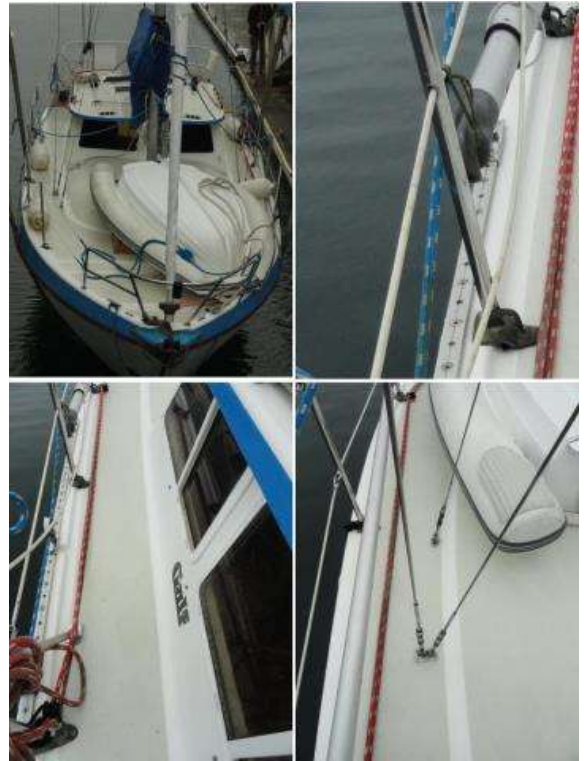
Molded, cored fiberglass deck and side deck construction (core not sampled). Fiberglass pilothouse roof is identical construction. White gel coat with molded in swirl-pattern non skid fiberglass surface with grey gelcoat. Good condition. Deck is solid under foot, no soft spots discovered and no visible cracks or chips sighted.

Moisture meter readings on top and side decks and surrounding thru deck fittings were relatively dry with normal comparative moisture meter readings. No Delamination discovered when randomly testing with percussion hammer. Moisture meter readings on top and side decks and surrounding thru deck fittings were relatively dry with normal comparative moisture meter readings. EXCEPT: slightly elevated moisture in way of chainplates on both side-decks; percussion-tapping in that area does not suggest separation of deck layers, and is solid underfoot; **RECOMMENDATION: rebed chainplates, deck thru-bolts, and chainplate covers to lessen any further moisture ingress.** No Delamination discovered when randomly testing with percussion hammer. EXCEPT: small 4"x6" dia area of delamination of top skin from core, found just forward of foredeck sliding hatch frame. No higher moisture readings in thee areas; slight cracking of deck surface at periphery of delaminated area , solid underfoot. May have been a manufacturing defect. **RECOMMENDATION: to avoid spreading of the delamination, a cautious approach would be epoxy-injection to re-bond deck layers; as there is no high-moisture present, this area is a likely candidate for this method of repair.**

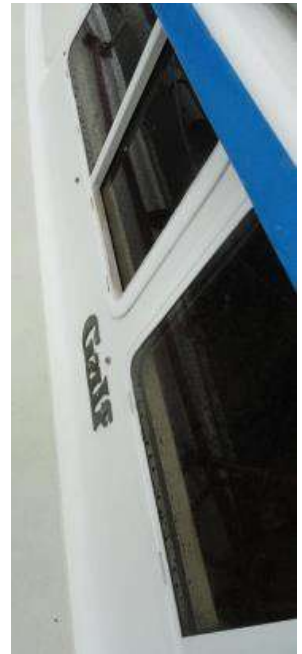
Fixed side windows. Sliding side windows. No evidence of UV-crazing; plastic frames well-sealed to exterior fiberglass. Reported to be new.

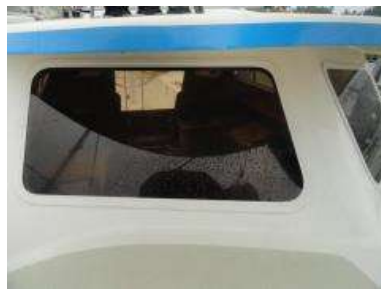
Large two piece plastic framed; No cracks or separation sighted and is well secured.

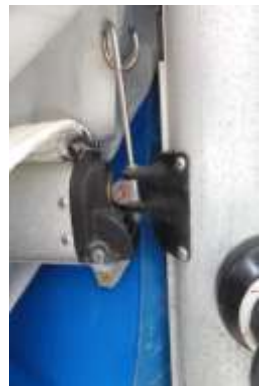
Stainless steel and cast-aluminum - Well secured and no signs of abnormal wear.

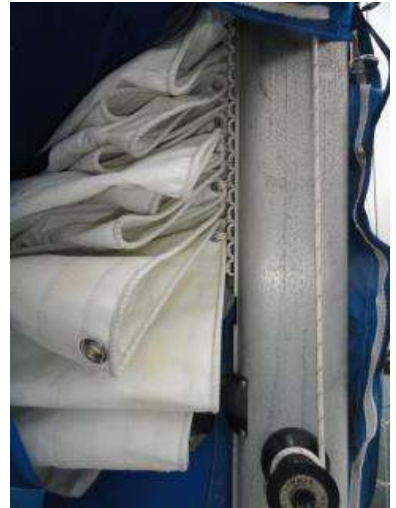
Sail flaked on boom covered with canvas sail cover. Not raised for inspection but only partially examined.

**Reported to be new.** Appears in very good condition based on partial inspection. Crisp cloth still very full of stiffening resin; no apparent wear.

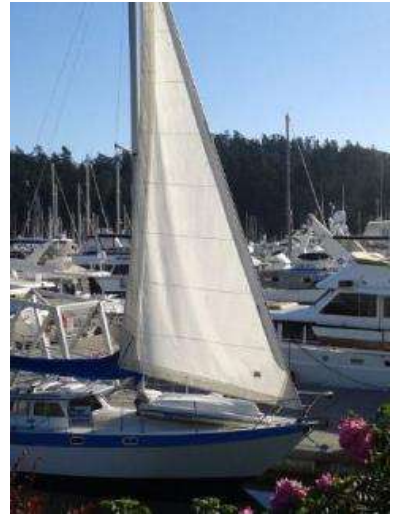
Roller furling sail Genoa, with modern thin vinyl UV panel secured to sail leech and foot. photo taken by broker on previous day)

Appears in good condition, no holes or split seams sighted and head, tack, clew and grommets intact. Serviceable. Slight green-algae staining at outermost roll; suggest hand-cleaning.

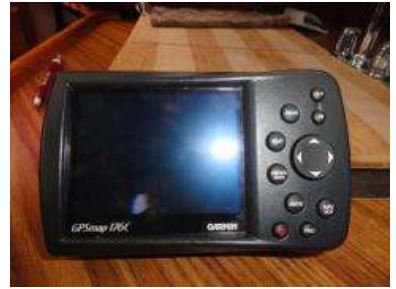
Found loose in bag inside cabin: Garmin GPSMap 176c - powers up using internal batteries.

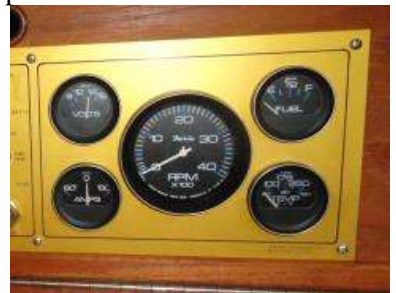
**Engine status:** OEM Faria Instruments, mounted at nav-table inside pilothouse. No instruments in cockpit. Includes tachometer, volts, amps, fuel, and engine temp. All appear to be functional (though amps is suspect)

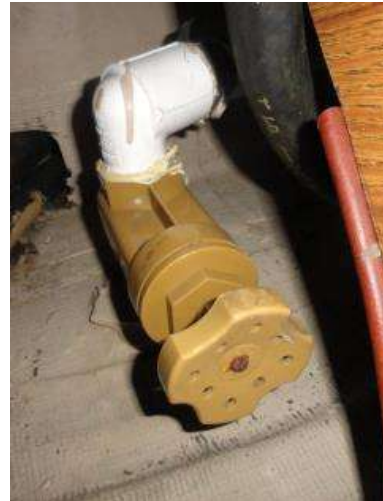
**Transom mounted:** Deck drains.

**Sea valves:** Plastic gate valve(s) installed; these are above waterline at rest, but may be below waterline when heeled. . ----- ABYC H-27 "Seacocks, Thru-hull Connections and Drain Plugs" recommends in part that all sea valves be of the lever activated type; Ball valve type is preferred. Gate valves are not recommended as they jam easily and open/closed status cannot be visually discerned. **RECOMMENDATION:** *replace these gate valves with marine bronze ball-valves at next service haul-out. . Note: all below the waterline seacocks should be double clamped, but only if the nipple is long enough to support the second clamp. In addition, ensure all hose clamps are free of rust and corrosion and are securely fastened. Tapered wooden plugs of the appropriate size should be readily accessible for emergency use at each seacock location.*

*NOTE: When replacing gate valves, If Marelon is used, the manufacturer recommends replacement of the through hull fitting with one of Marelon as well.*

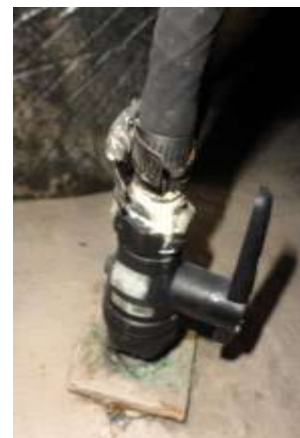
**Sea valves:** Marelon seacock ball valve(s) installed, Sea valves sighted are used for: Engine raw water intake.

**Sea valve condition:** Sea valve is functional. *NOTE: All sea valves should be moved from one setting to the other a few times at least once a month to ensure that they will be in usable condition.*

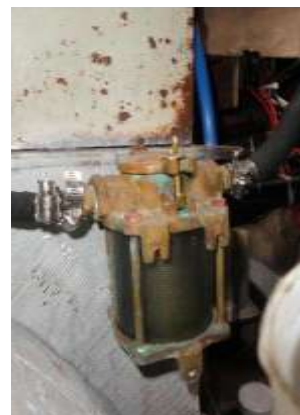
**Sea strainers:** Internal strainer, installed for engine raw water. No leakage observed. Some fouling by eelgrass, but cleared at time of survey (buyer is trained in operation)

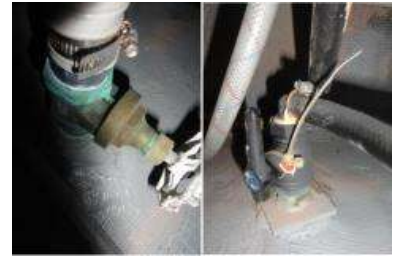
Two Bronze gate valve(s) installed, one for forward manual bilge pump, one for overboard sewage discharge (Y-valve ahead of this is properly disabled for no overboard discharge). **RECOMMENDATION:** see note above for replacement of all gate valves with sea-valve that gives clear indication of open/closed status. One Marelon ball valve installed for head raw-water intake.

Marelon ball valve is functional. Gate valves appear to be functional but cannot ascertain for certain. (See above note regarding use of Gate Valves)

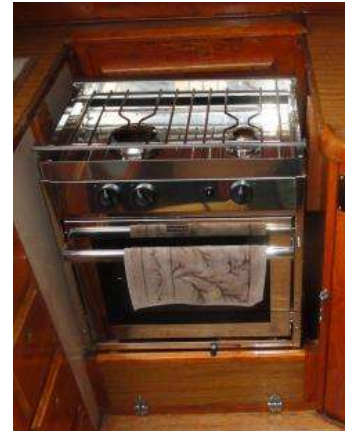
**Stove:** Force10 two burner (newest version - appears unused) sealed-top, LPG, with oven, Burners tested and are functional. Igniters spark OK. Flame-loss shutdown tested and found operational.

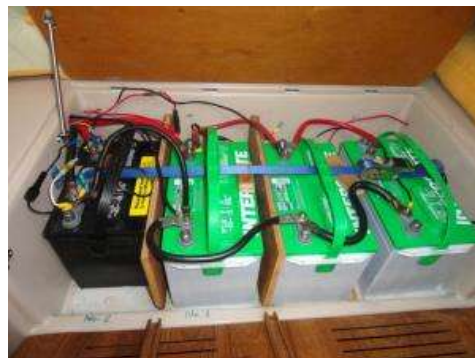
**Batteries:** Three, gp 27 Interstate flooded-cell lead-acid batteries, providing service to the house electrical. Reported to be new. Batteries are wired in parallel producing 12 volts. Batteries are well secured in dedicated fiberglass well providing containment of incidental spillage, with straps. Cables are properly color coded. Positive terminal(s) not covered as required. **RECOMMENDATION: Code of Federal Regulations - CFR33.183.420 mandates that positive terminals be protected against accidental shorting by the use of insulation barriers or sleeves or with battery case cover.**

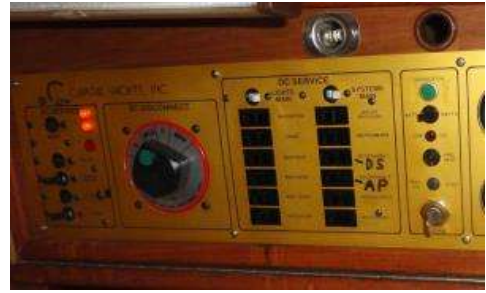
**Breaker(s)/fuse(s):** All D.C. circuits are adequately protected by branch or switched breakers. (note there are only two breakers -- one for all lighting circuits, one for all systems circuits -- this minimal approach satisfies ABYC recommendations, but may not provide clear indication WHICH circuit has failed -- *consider replacing "DC Service" section of panel with new BlueSeas panel providing separate circuit breaker for EACH separate DC circuit, now selected only by switches, for easier troubleshooting.*) However, Cables up to distribution panel are not over-current protected (may not have been required at time of vessel-build) **RECOMMENDATION: provide over-current protection (fuse) sized for max amp capacity of feed cable to rotary switch, within 7" of house battery bank, according current ABYC E-11 recommendations.** *One way to provide overcurrent protection for the cables coming from battery to distribution panel, is with Blue Seas' new MRBF fuse system, that mounts right on the positive battery terminal. Consult supplier for what size fuse, based on max ampacity of size of cable (which I didn't record). Note: start cable does not need overcurrent protection.*

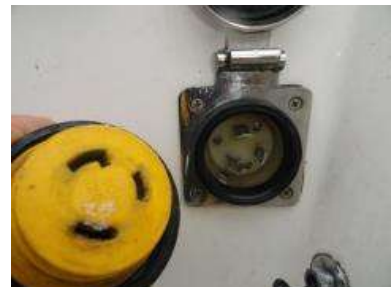
**Shore power cord(s):** Marincos, 30 AMP shore power cord-length not measured. Condition of plug is serviceable; no burn marks. **NOTE:** *Doing a regular inspection of your power cords is a good way to ensure that they haven't incurred heat damage that could start a fire aboard your boat. When examining your cords, start at the ends and look for brown discoloration at the base of the blades - a clear indicator of excessive heat. (Blades with*

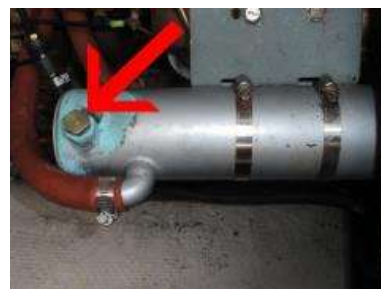
**Cooling system(s):** Fresh water / heat exchanger cooled, -- coolant level is full and appears to be in good condition. (remember to check and renew as required, the sacrificial zinc anode noted in photo)

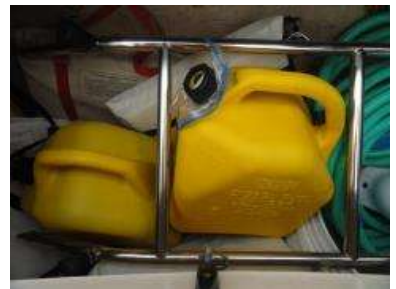
**Other notes:** Two portable plastic diesel fuel tanks found (full) in aft lazarette. One is missing its cap, and is closed only with plastic over-wrap. Portable fuel tanks should not be stored in an area that would drain into bilge upon leakage. **RECOMMENDATION: store these portable fuel tanks on-deck, such that spillage would run overboard.**

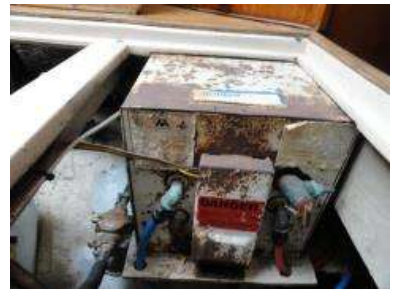
**Manufacturer/capacity:** Tank was built by: Atwood The capacity is 6 US gallons.

**Outer tank material:** Mild steel, painted. *Considerable rust on surface; consider wire-brushing and painting to preserve.*

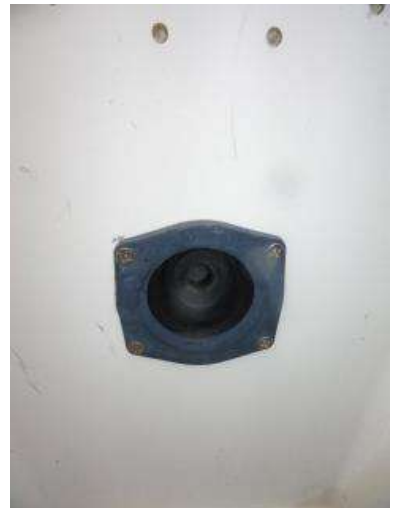
A second Whale manual pump found inside starboard lazarette. Manual bilge pump handle was sighted on board. *NOTE: Handle should be located in vicinity of pump to use when required.*

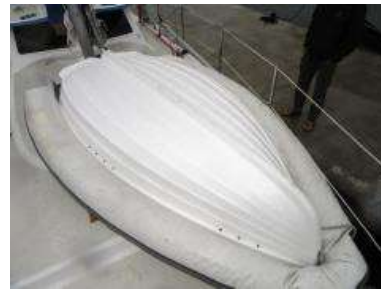
**Type:** Pressure-Molded plastic rowing dinghy, with inflatable floatation tubes installed both sides. Modified with factory deflector trim-tab for better outboard powering.

**State registration no:** Registration not sighted.  
**Condition:** Overall appears in Good serviceable condition. beginning of some UV-deterioration on underside of PVC tubes (typically stored upside-down on foredeck, as seen in photos)
